AGARD CONFERENCE PROCEEDINGS 550

Composite Repair of Military Aircraft Structures

Papers presented at the 79th Meeting of the AGARD Structures and Materials Panel, held in Seville, Spain 3-5 October 1994

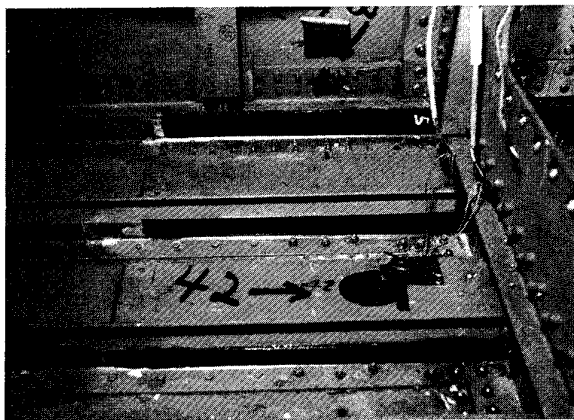
Figure 13. Boron/Epoxy Strip Modification - Inboard of BL 61

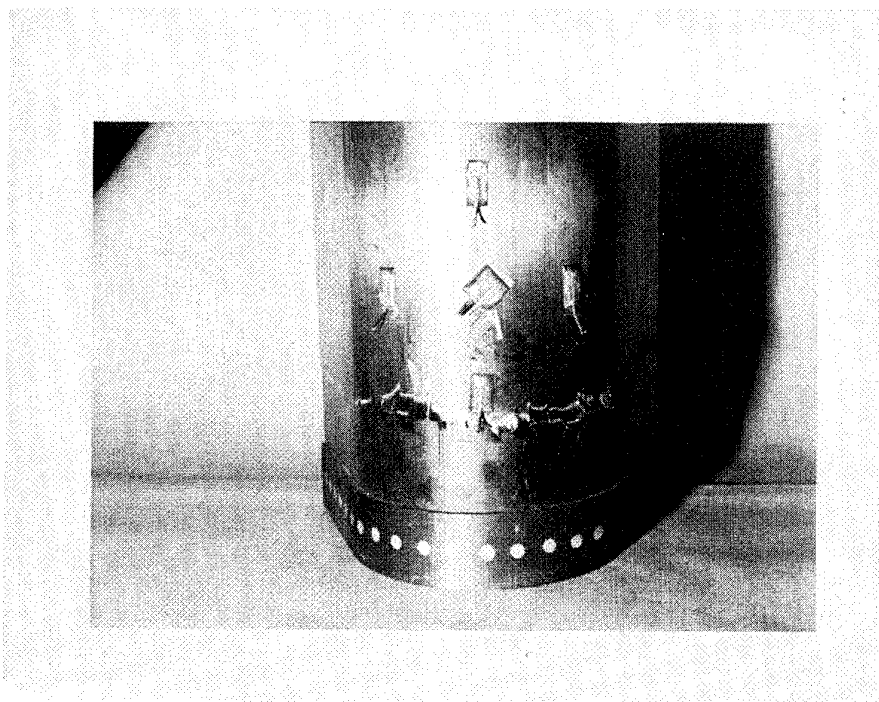
Figure 11. RTD Baseline Failure
